TOPOGRAPHIC SURVEY
CLIENT: ARKANSAS STATE UNIVERSITY
 LOT 1 AND PART OF LOT 2 OF BLOCK 1 OF OLIVER DAVIS ADDITION
 TO THE CITY OF TYRONZA, POINSETT COUNTY, ARKANSAS

1. THIS PROJECT IS FUNDED BY A GRANT RECEIVED FROM THE ARKANSAS NATURAL & CULTURAL RESOURCES COUNCIL. IT INVOLVES THE ADAPTIVE RE-USE OF AN ABANDONED SET OF GRAIN BINS AND OTHER STRUCTURES INTO A NEW FACILITY SUPPLEMENTING THE EDUCATIONAL OPPORTUNITIES OF THE SOUTHERN TENANT FARMERS MUSEUM, ONE OF SEVERAL ARKANSAS HERITAGE SITES RUN BY ARKANSAS STATE UNIVERSITY. THE PURPOSE OF THE PROJECT IS TO ALLOW THE MUSEUM TO EXPLAIN TO VISITORS, INCLUDING SCHOOL-AGED CHILDREN, HOW THE GRAIN BIN WORKED AS A PART OF AGRICULTURE IN THE NORTHEAST ARKANSAS ECONOMY. AS SUCH, IT WILL BE A HIGH PRIORITY FOR THE PROJECT TO MAKE THE BUILDINGS, RAMP AND IMMEDIATE SURROUNDINGS SAFE FOR CHILDREN AND THE PUBLIC. IT IS ALSO ANTICIPATED THAT THE NEW FACILITY CAN HAVE THE DUAL PURPOSE OF SERVING AS A VENUE FOR PUBLIC AND PRIVATE EVENTS SUCH AS WEDDINGS, CLASS REUNIONS & OTHER GATHERINGS.

ARCH. SITE PLAN
SCALE: 1/16" = 1'-0"
NORTH

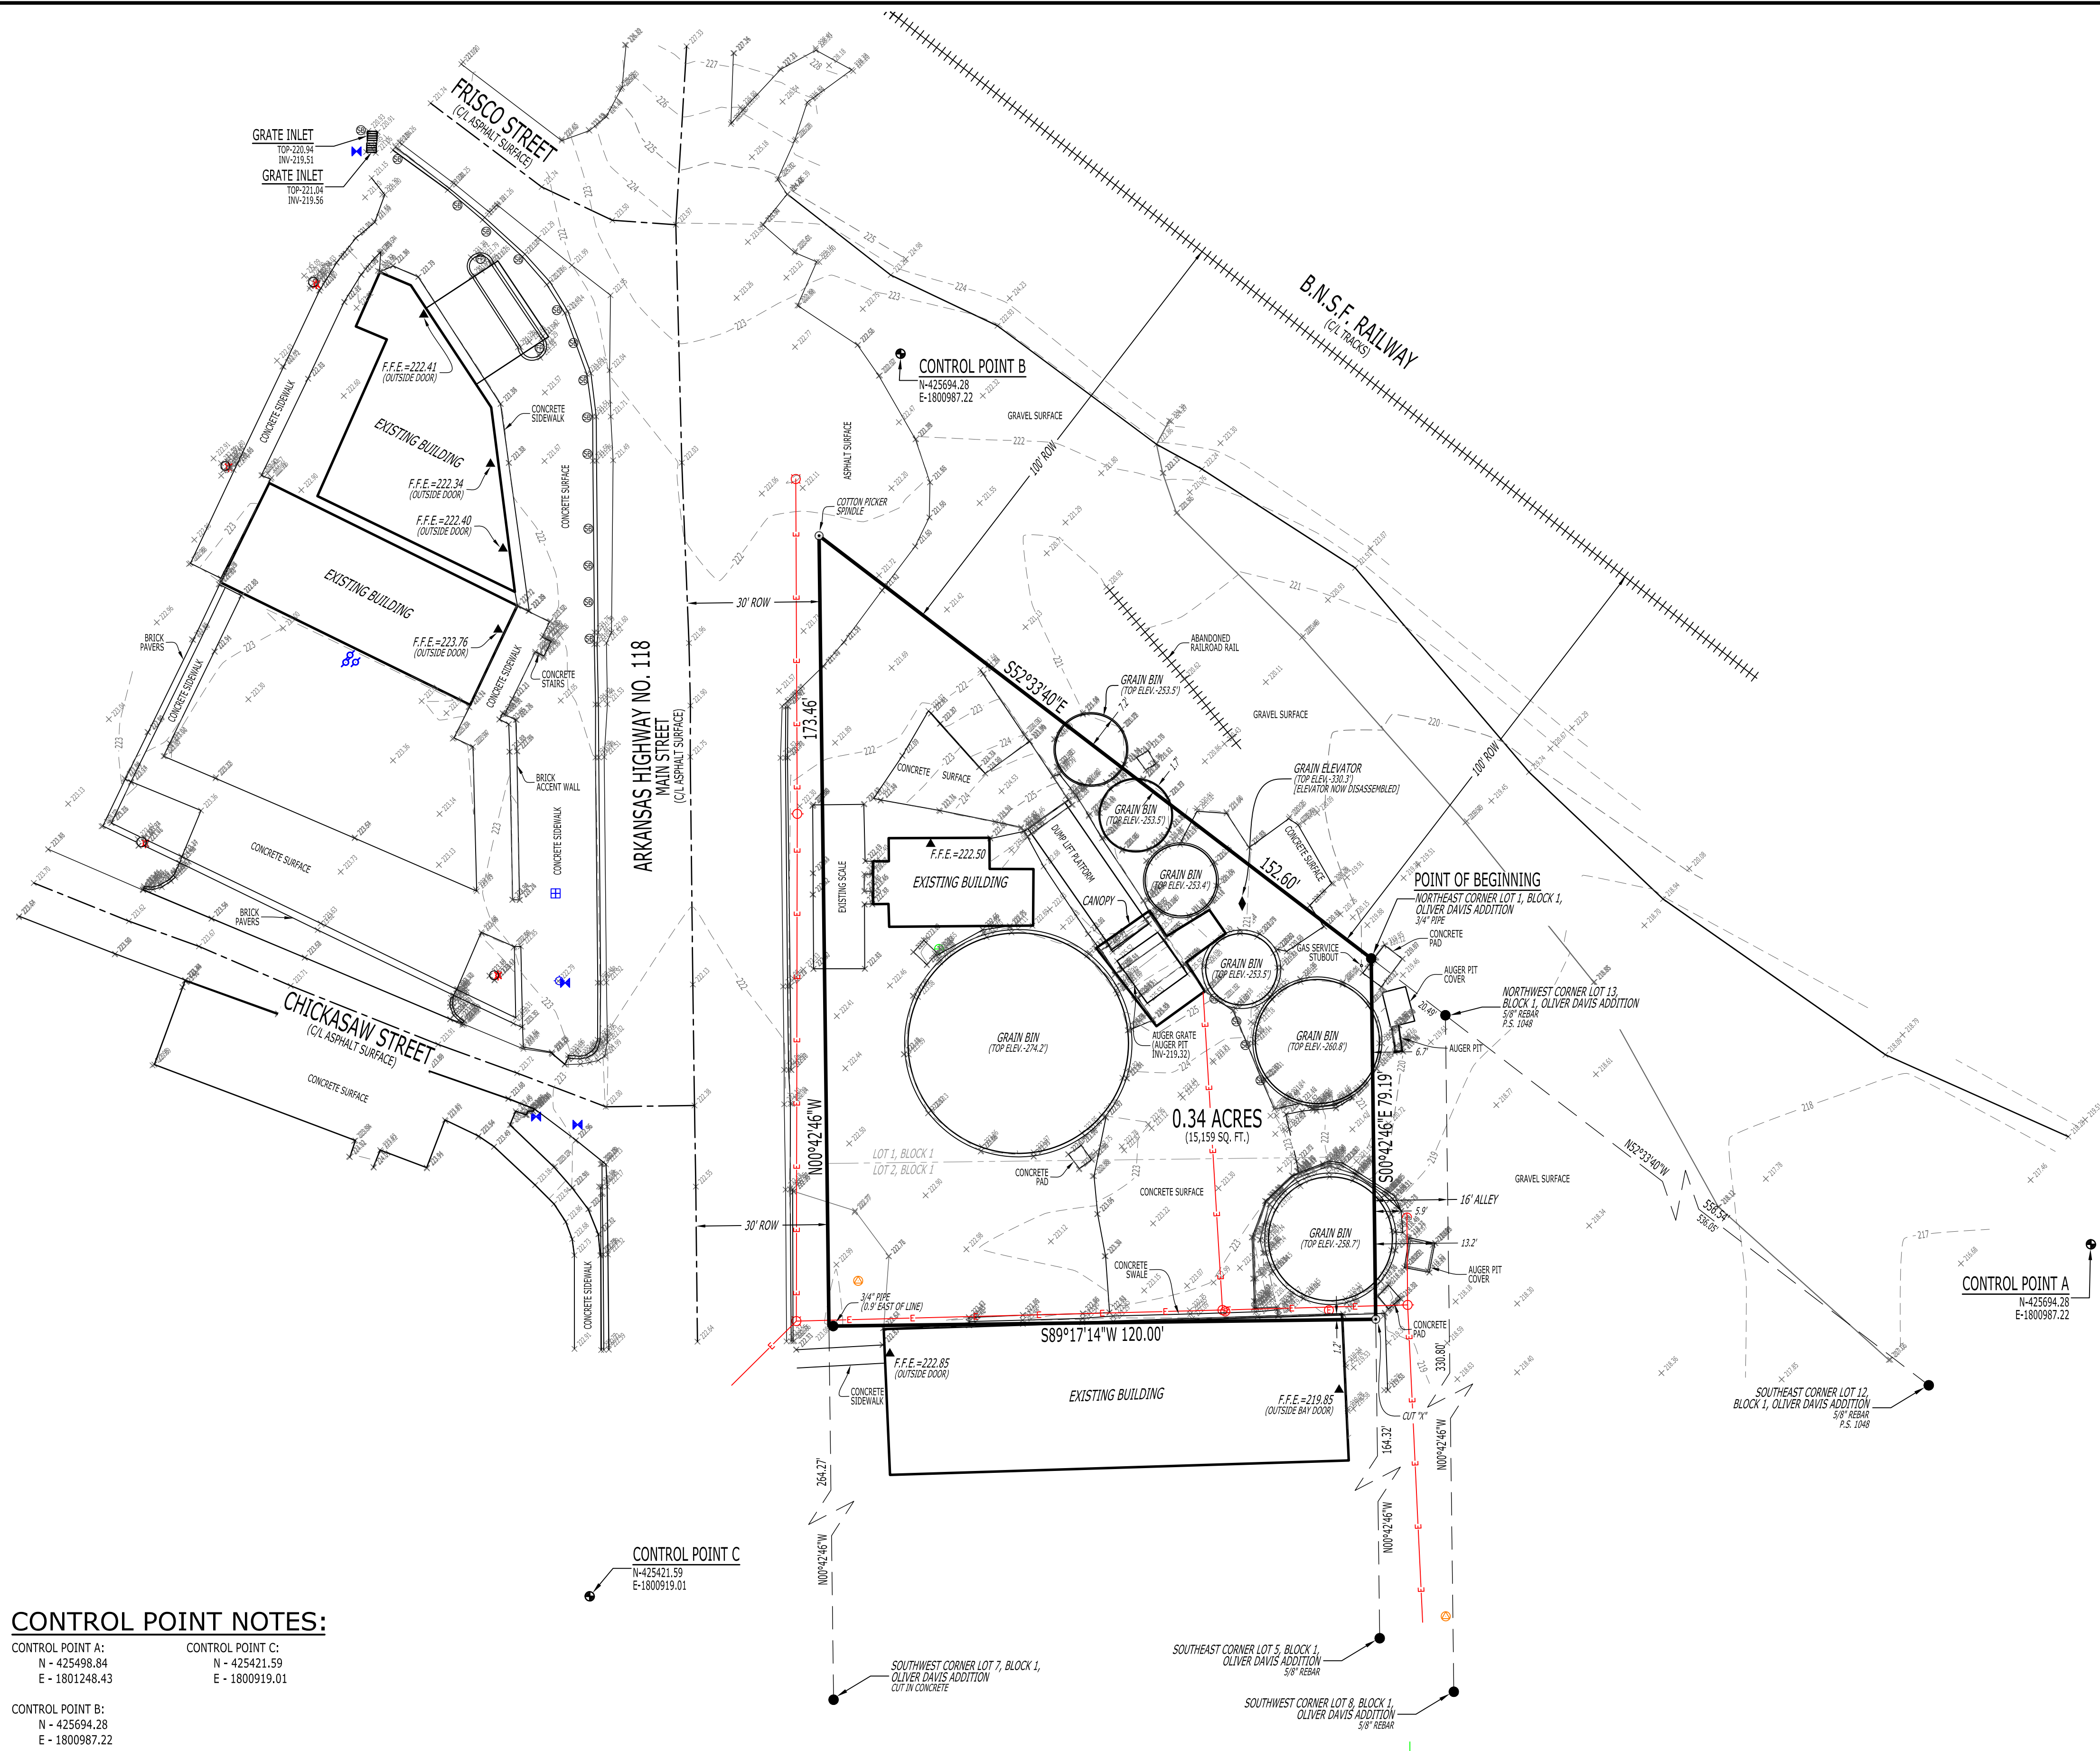
SITE BENCHMARK NOTE:
SITE BENCHMARK IS THE NORTH RIM OF A SANITARY SEWER MANHOLE (ELEVATION = 218.32), LOCATED SOUTH AND EAST OF THE SUBJECT PROPERTY, AS SHOWN ON THE PLAT HEREON.
