White River Apartments  
Diaz, AR

### **Addendum #2**

# **ASBESTOS INSPECTION REPORT**

**White River Apartments  
*located at*  
2900 Marion Drive  
Diaz, Arkansas 72112**

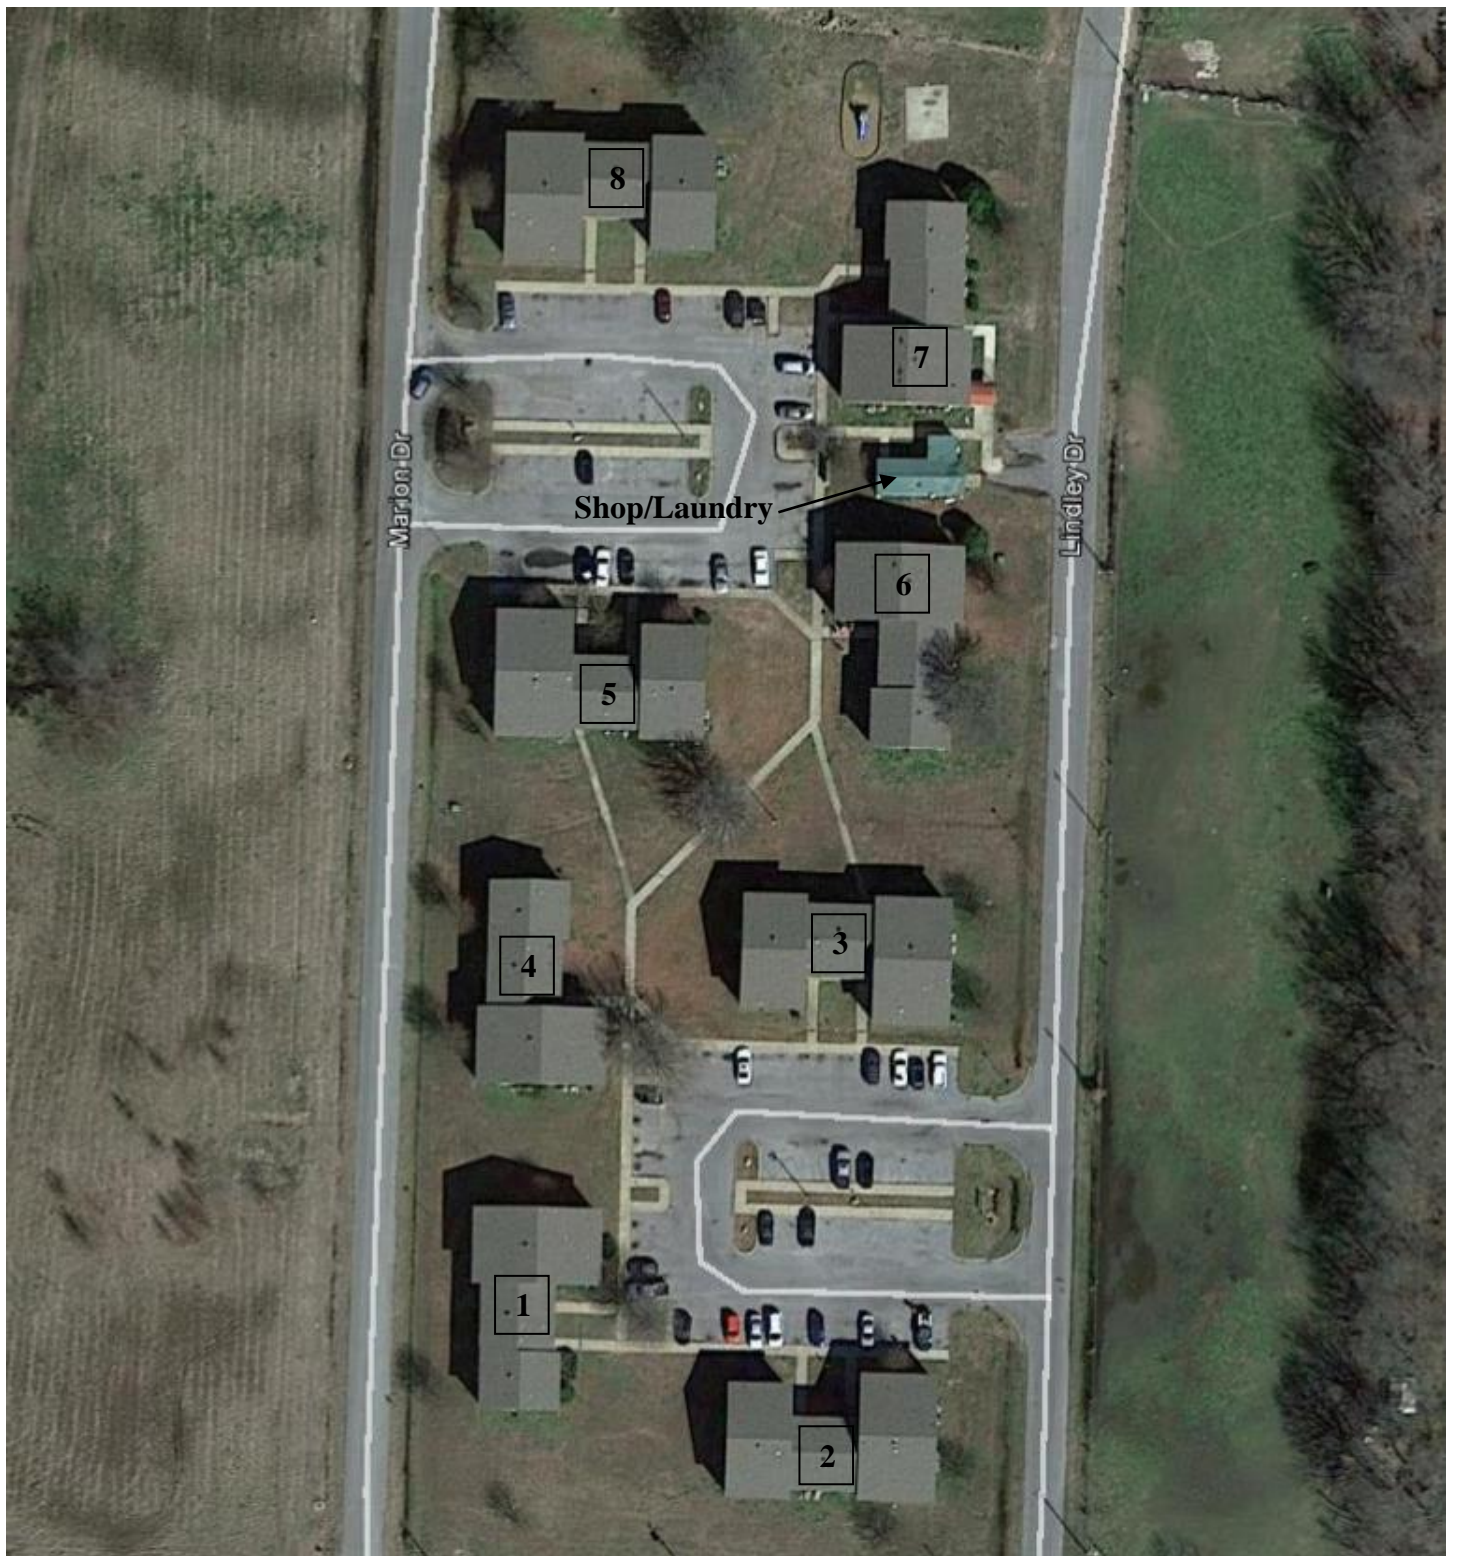
## **A. BUILDING LOCATION PLAN**

## Building Location Plan
