THIS PROJECT IS FUNDED BY A GRANT RECEIVED FROM THE ARKANSAS NATURAL & CULTURAL RESOURCES COUNCIL. IT INVOLVES THE ADAPTIVE RE-USE OF AN ABANDONED SET OF GRAIN BINS AND OTHER STRUCTURES INTO A NEW FACILITY SUPPLEMENTING THE EDUCATIONAL OPPORTUNITIES OF THE SOUTHERN TENANT FARMERS MUSEUM, ONE OF SEVERAL ARKANSAS HERITAGE SITES RUN BY ARKANSAS STATE UNIVERSITY. THE PURPOSE OF THE PROJECT IS TO ALLOW THE MUSEUM TO EXPLAIN TO VISITORS, INCLUDING SCHOOL-AGED CHILDREN, HOW THE GRAIN BIN WORKED AS A PART OF AGRICULTURE IN THE NORTHEAST ARKANSAS ECONOMY. AS SUCH, IT WILL BE A HIGH PRIORITY FOR THE PROJECT TO MAKE THE BUILDINGS, RAMP AND IMMEDIATE SURROUNDINGS SAFE FOR CHILDREN AND THE PUBLIC. IT IS ALSO ANTICIPATED THAT THE NEW FACILITY CAN HAVE THE DUAL PURPOSE OF SERVING AS A VENUE FOR PUBLIC AND PRIVATE EVENTS SUCH AS WEDDINGS, CLASS REUNIONS & OTHER GATHERINGS.

REVIVAL Architecture	P.O. Box 400, Scott, AR 72142 (501) 951-3316 www.revivalarch.com _{S.D.G.}
Contraction of the second seco	CHITTECT RE, STA
M GRAIN BIN RESTORATION	TYRONZA, ARKANSAS 72386
Project Name: SOUTHERN TENANT FARMERS UNION MUSEUI	Sheet Contents: ARCHITECTURAL SITE PLAN & GENERAL NOTES
Issue Date: March I, 2024 Revi

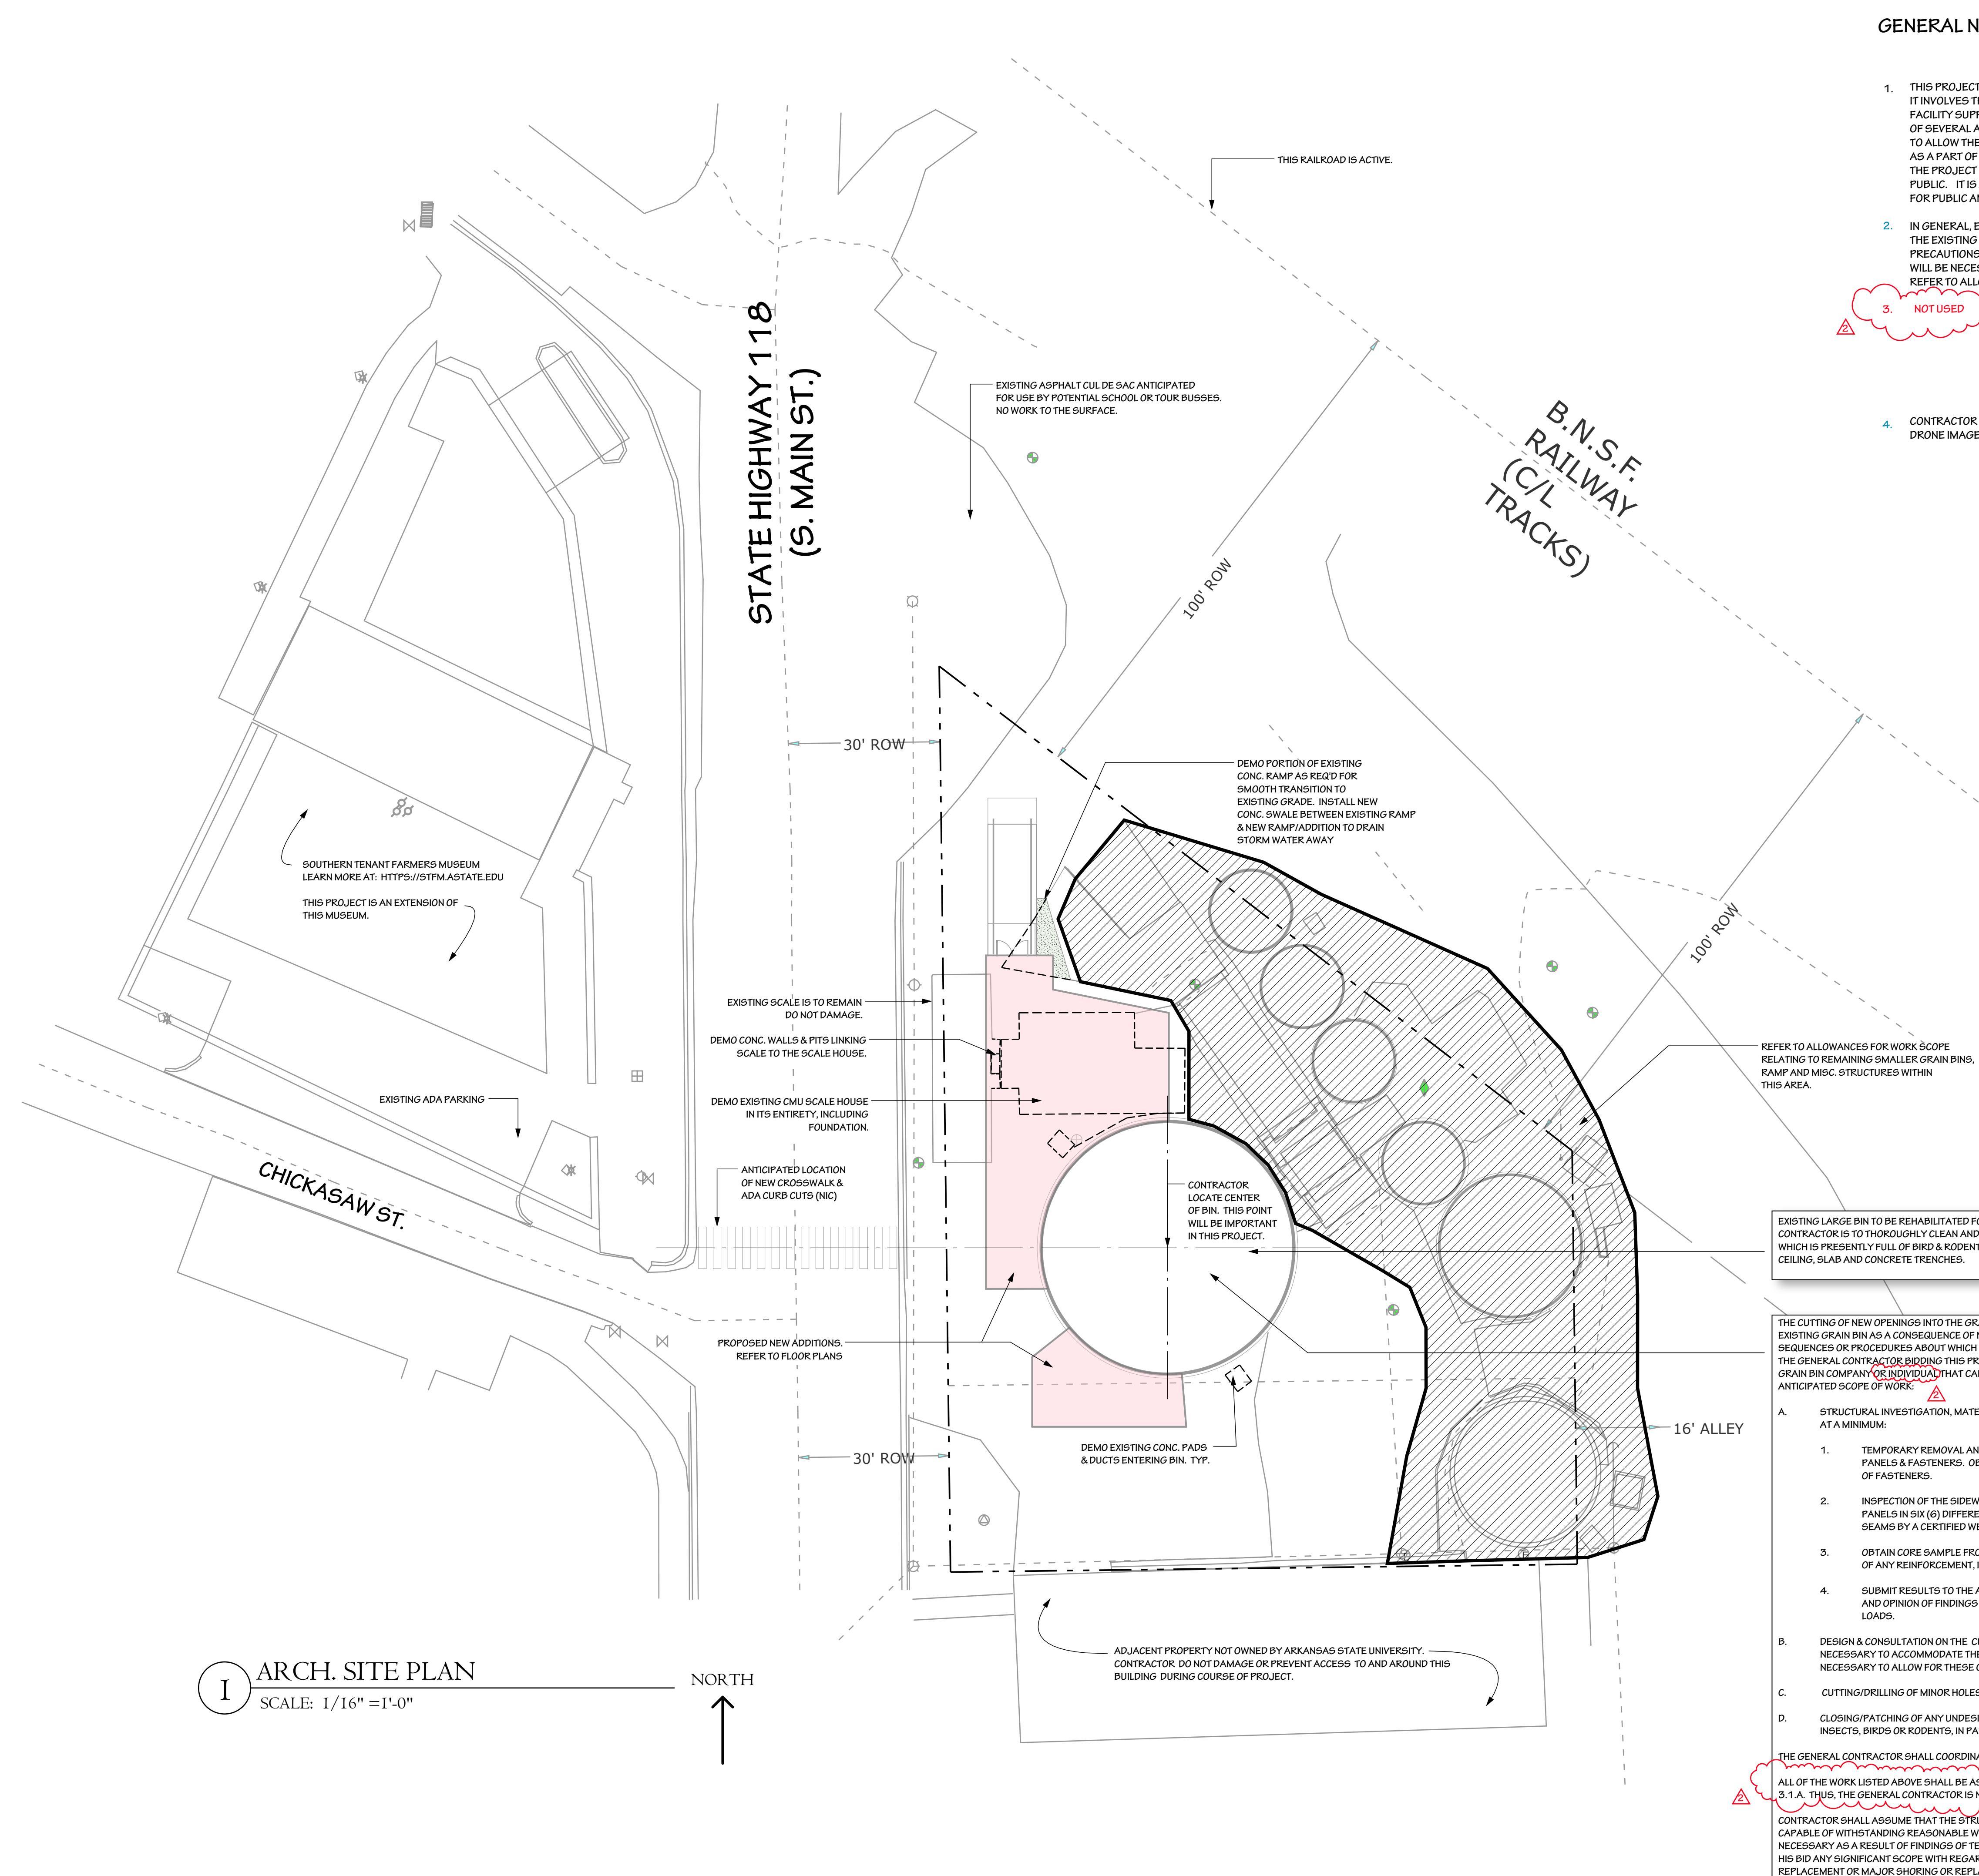
EXISTING LARGE BIN TO BE REHABILITATED FOR NEW, OCCUPIED SPACE. CONTRACTOR IS TO THOROUGHLY CLEAN AND SANITIZE THE EXISTING INTERIOR, WHICH IS PRESENTLY FULL OF BIRD & RODENT DROPPINGS, INCLUDING WALLS,

DESIGN & CONSULTATION ON THE CUTTING OF NEW LARGE OPENINGS INTO THE SIDEWALL OF THE GRAIN BIN, AS IS NECESSARY TO ACCOMMODATE THE NEW DOORWAYS SHOWN. ASSUME SOME NEW STEEL STRUCTURE WILL BE NECESSARY TO ALLOW FOR THESE OPENINGS W/O COMPROMISE TO THE SHELL OF THE GRAIN BIN.
